Impact of Encroachment on Natural Drainage for Vadodara City

Abstract

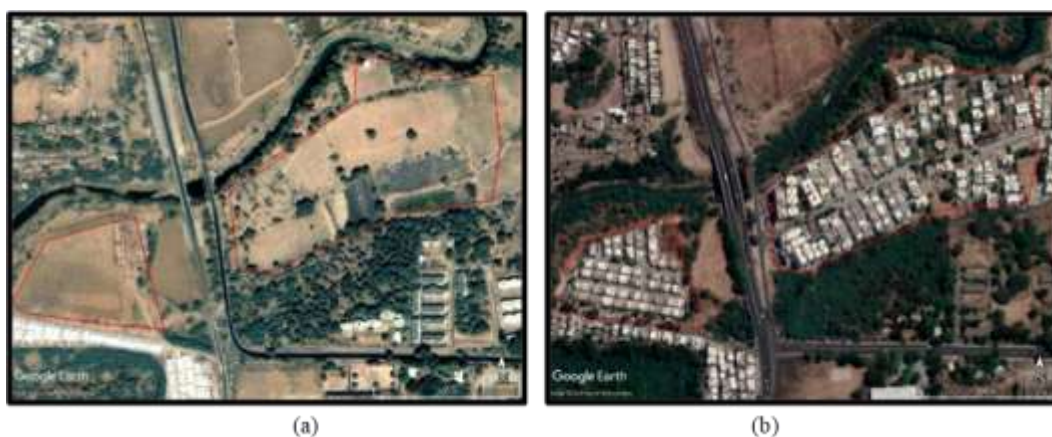
Fig. 2: Built-up near Amitnagar bridge (a) 2000 (b) 2019

Disturbed Waterways and Flood Plains: The development of the city is at rapid pace in the last two decades. Change in land use near flood plains of river and flood inundated areas in the city is done by comparing the oldest available Google earth image (28th October 2000) and the recent one (29th May 2019). High end bungalows near Amit nagar bridge (Fig. 2) are affected badly almost every time whenever there is a high water level in the river. High economic losses are observed during each flood. Another colony of bungalows (Fig. 3) at upstream of Munjmahuda bridge is facing the same difficulty.

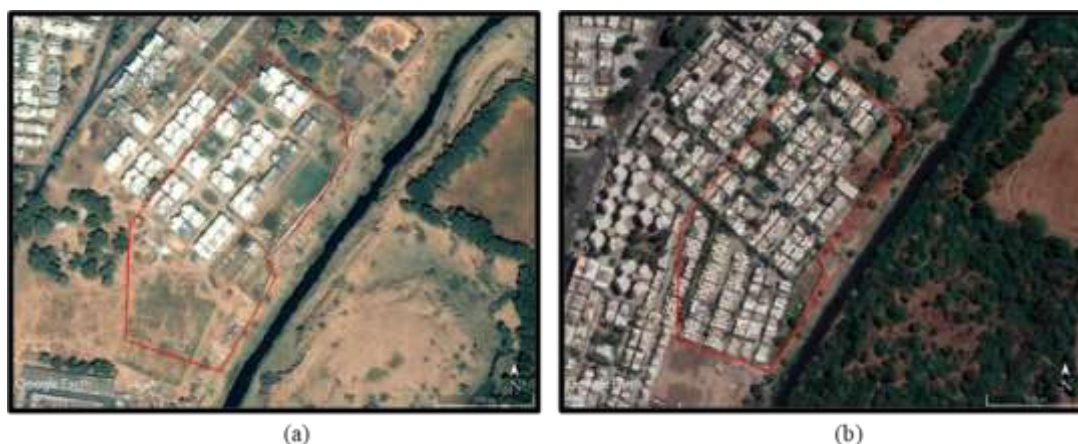
Fig. 3: Built-up near Munjmahuda bridge (a) 2000 (b) 2019

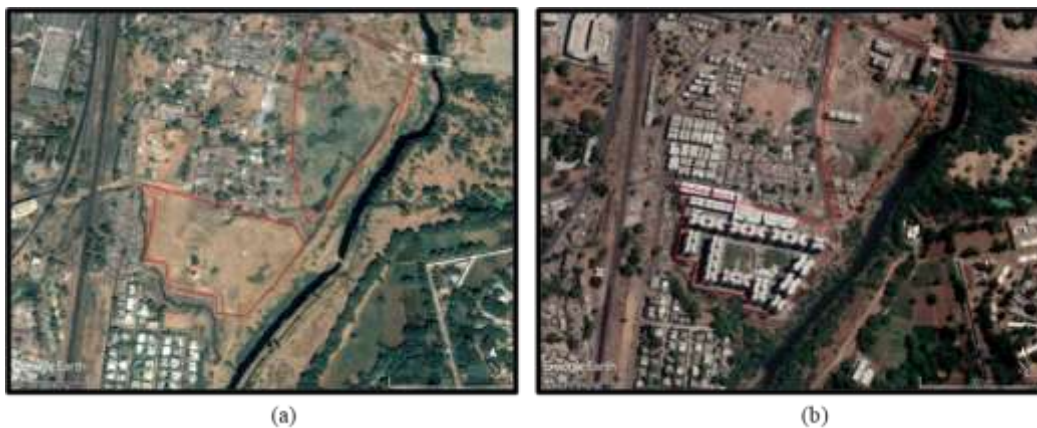
Fig. 4: Construction near Bhimnath bridge (a) 2000 (b) 2019

Comparatively recent construction is developed near Bhimnath bridge (Fig. 4) on the land which was served as inundation pond during high floods. The outfall of Parshuram nagar rivulet also seems affected due to this construction. Impervious area is increased due to

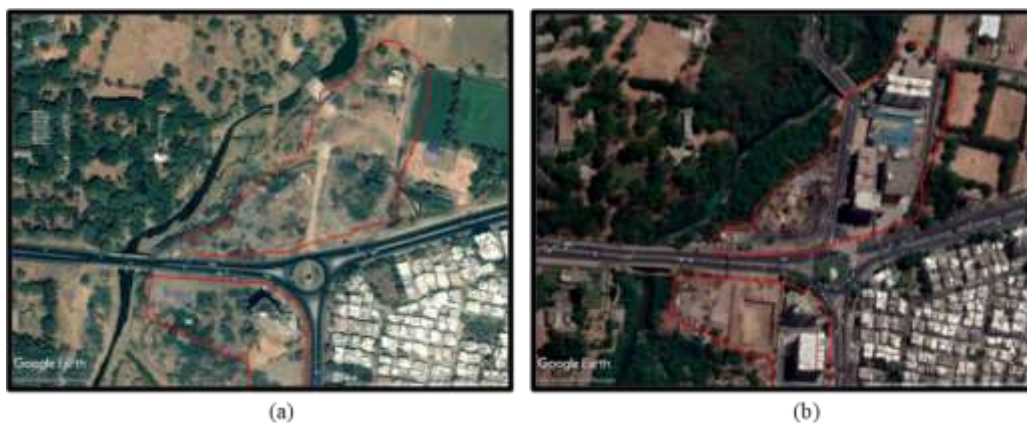
Fig. 5: Construction near EME bridge (a) 2000 (b) 2019

construction of food market (Fig. 5) and other buildings near EME bridge.

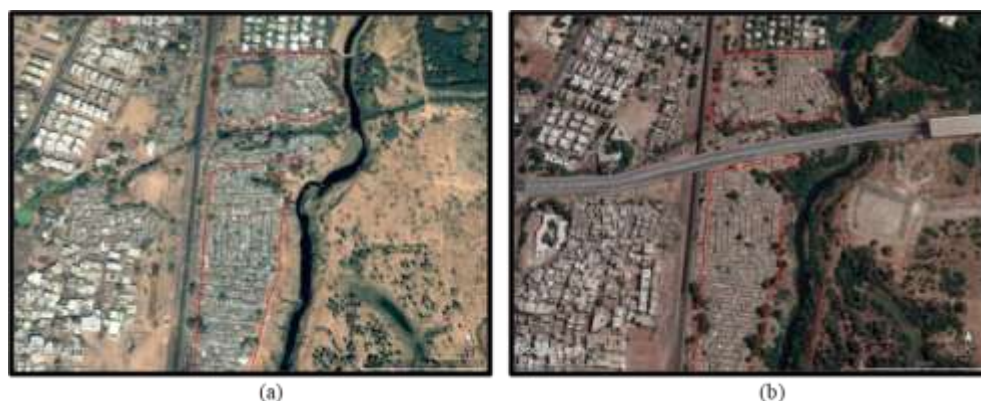
Fig. 6: Slum near Akota bridge (a) 2000 (b) 2019

Slum near newly constructed Akota bridge is one of the oldest dense slum (Fig. 6). This slum is affected during high floods in the river. Slum at the downstream of Munjmahuda bridge (Fig. 7) is expanded over the space which previously served as inundation pond.

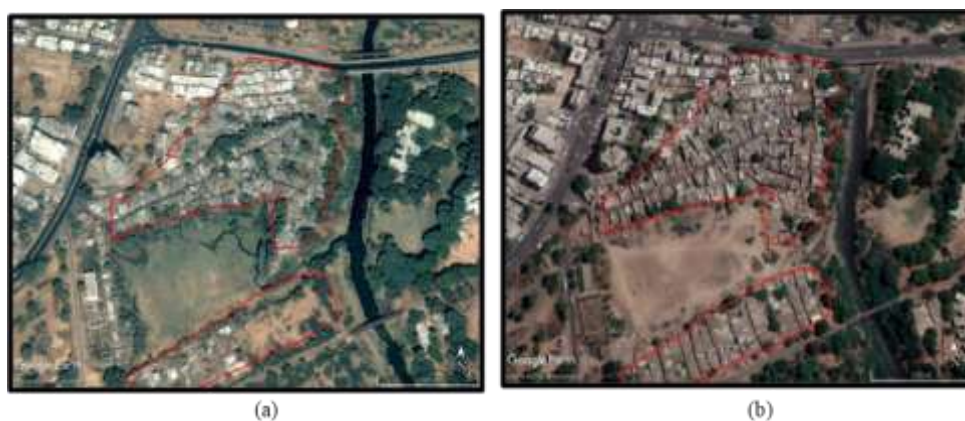
Fig. 7: Slum near Munjmahuda bridge (a) 2000 (b) 2019

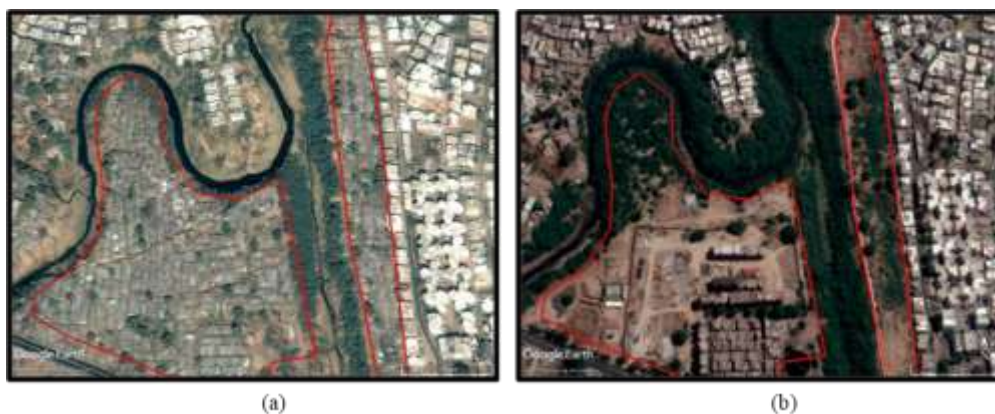
Fig. 8: Slum evacuation near Narhari Hospital Bridge (a) 2000 (b) 2019

Slum rehabilitation programme is being executed by public private partnership. Under this scheme slum on the banks of river is evacuated. Slum dwellers are shifted to other places and provided with the basic facilities by private developers, in turn developer can develop evacuated land or get more FSI in other construction projects. Evacuation of slum on both the banks of river near Narhari Hospital Bridge can be seen in fig. 8. Slum near Mangal Pandey Bridge is removed and construction has been started by a private developer (Fig. 9). Construction on river flood plain is clearly visible in the figure.

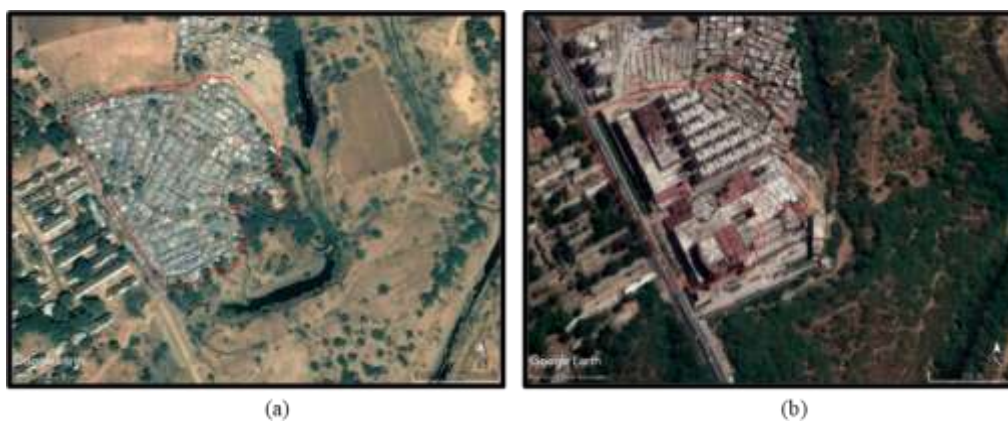
Fig. 9: Redevelopment near Mangal Pandey Bridge (a) 2000 (b) 2019

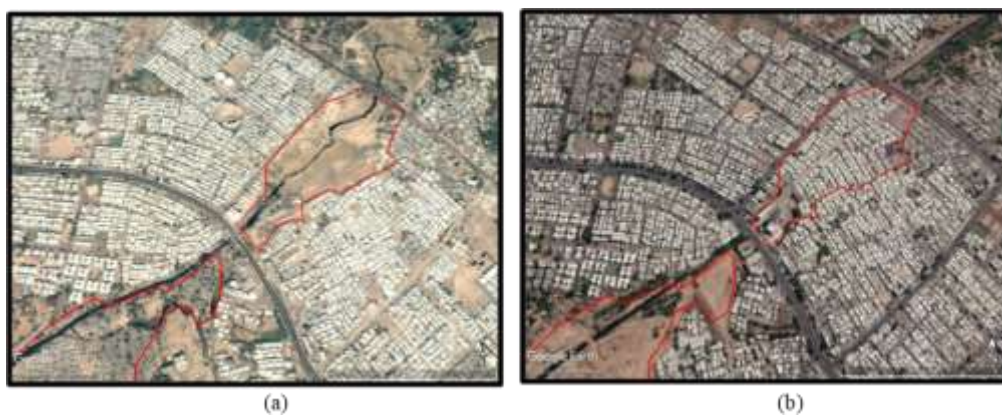
Fig. 10: Construction on rivulet flood plain at Varasiya (a) 2000 (b) 2019

The eastern part of Vadodara facing floods is not only due to local rainfall but also due to runoff from outside the urban boundary. Though slums are removed on the banks of rivulet (Fig. 10) at Varasiya, concrete built up has also increased on the floodplains of the rivulet. Slum encroachment was observed on the wetlands of Kishanwadi area (Fig. 11).

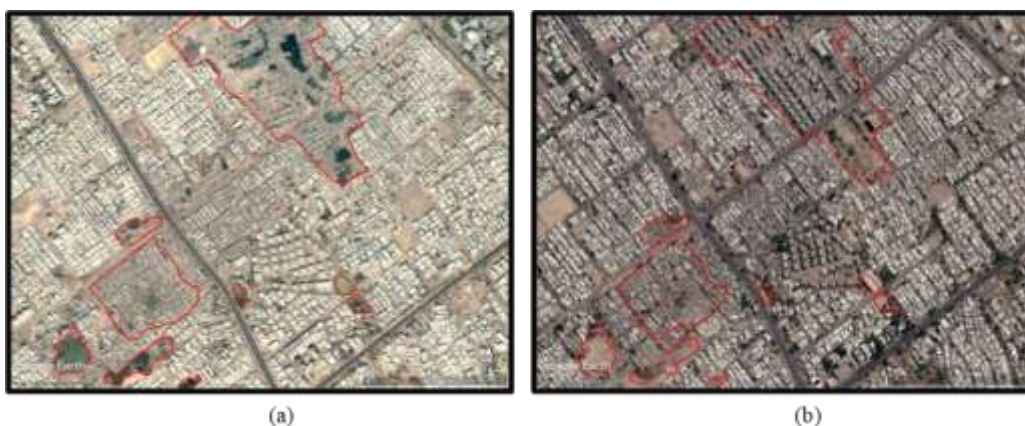
Fig. 11: Construction on wetlands of Kishanwadi (a) 2000 (b) 2019

These wetlands were used for flood inundation and helped in reducing vulnerability in the area. Though slums were removed, permanent residential structures were constructed on the same land.

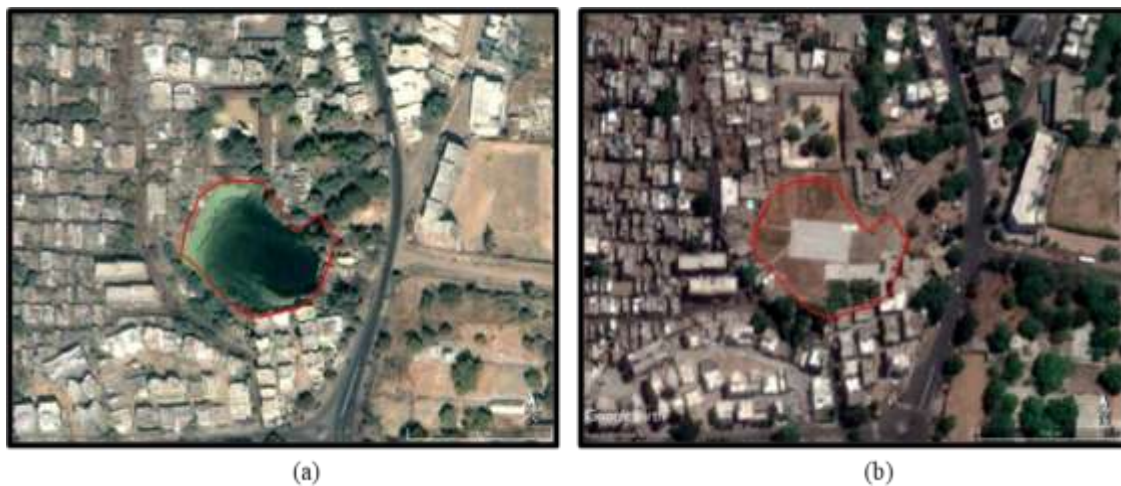
Fig. 12: Khanderao lake (a) 2000 (b) 2019

Lake revival project has been undertaken by local authority. It is the fact that urbanisation has affected natural slopes and drainage channels. Depletion of ground water has also affected undercurrents. Change in catchment topography has resulted in to drying of ponds. Khanderao Lake (Fig. 12) near Khanderao temple has dried and construction is done after filling up the land of the lake. Lake near Manjalpur funeral ground is also dried and road is constructed after land filling (Fig. 13). The remaining portion of the lake is rehabilitated.

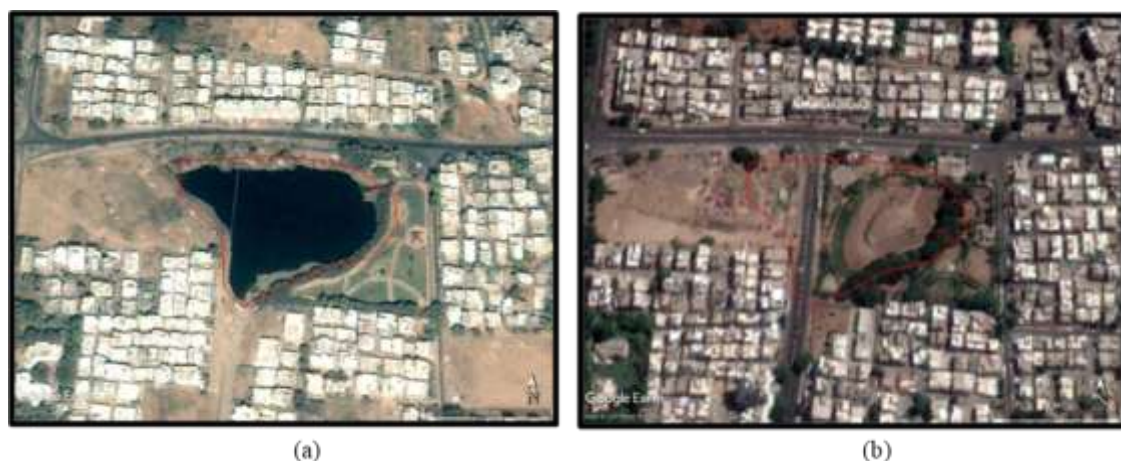
Fig. 13: Manjalpur lake (a) 2000 (b) 2019

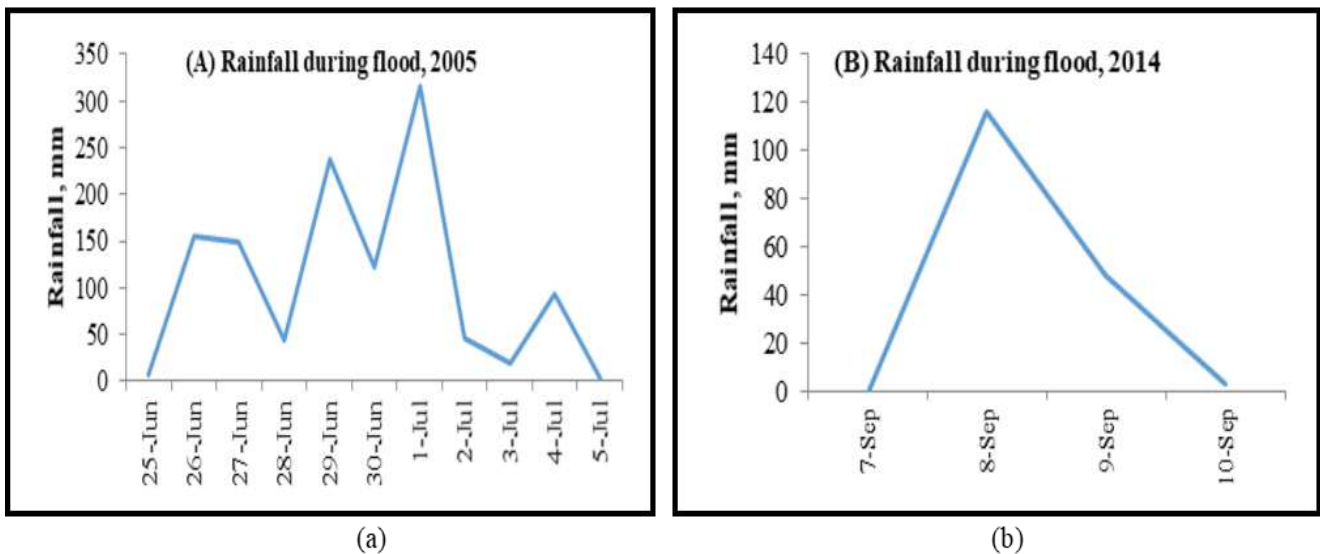
(a) (b)
Fig. 14: Daily Rainfall during flood (a) 2005 (b) 2014

Flood in 2005: Vadodara city receives the rainfall in in mid-June to mid-September; annual average rainfall is about 903 mm. This moderate rain region of central Gujarat received unprecedented rainfall of around 1200 mm due to upper air cyclonic circulation during 24 June to 4 July 2005. The total rainfall observed in 11 days is about 30 percent higher than the average annual rainfall of Vadodara.

Flood in 2014: Vadodara faced flood during 9th and 10th September 2014. Vadodara received 116 mm rainfall on 8th September. Due to high continuous rainfall in catchment area, overflow from Pratappura reservoir and release from Ajwa reservoir, the city was flooded for 48 hours in 2014. Viswamitri crossed High Flood Level on 9th September 3:00 p.m. Peak flood level 34.00 feet was observed on 10th September at 2:00 p.m. River water level was back to below HFL on 11th September after 10:00 pm.

Flood in 2005 occurred due to unprecedented heavy rainfall in the city as well as in the catchment area of Ajwa reservoir while there was comparatively less rainfall in the city with respect to reservoir catchment area in the flood of 2014. The severity of the water logging in the flood affected area was more or less same in some areas during both the flood events. The major reason for water logging can be identified as (a) due to high water level in the river, low lying flood prone areas were water logged. (b) no disposal of urban runoff water in the river due to high water level (c) less detention capacity of ponds, less inundation capacity of natural rivulets and vanishing of natural drains due to encroachment and land filling.

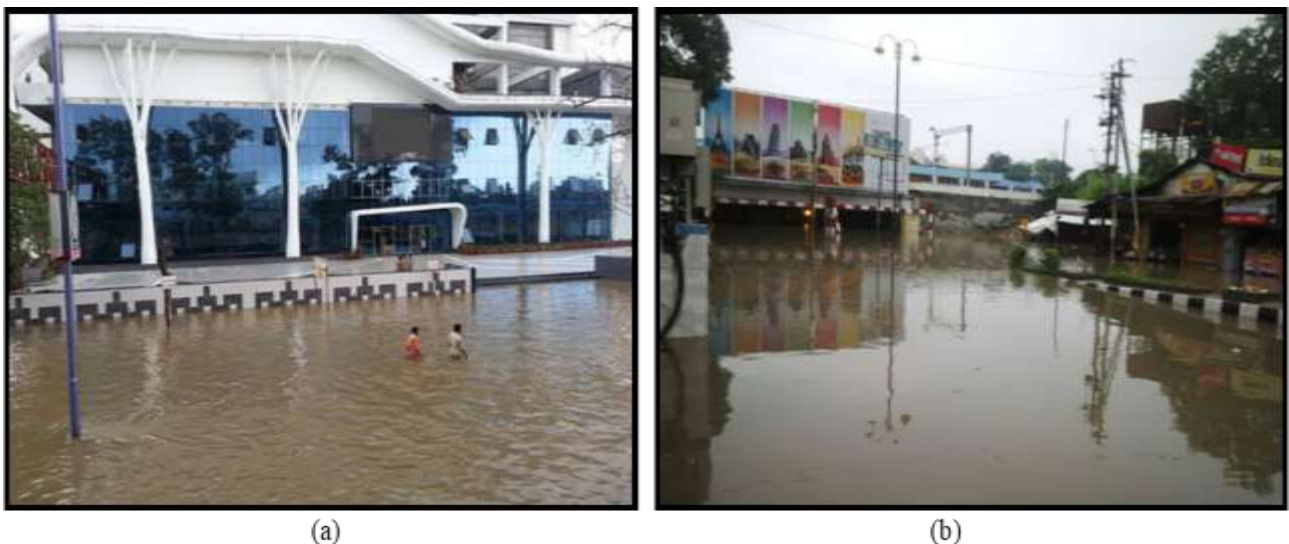
(a) (b)
Fig. 15: Water logging during 2014 flood (a) Central bus station (b) Railway station underpass

observed from rivulet near Ayurvedic College, Key transport and health facilities like central Bus station (Fig. 15 a), SSG hospital Road, Railway Underpass (Fig. 15 b) etc. were also affected by flood. Many of such areas namely old city area, Kapurai, Ataladra, Gotri, Gorwa, Chhani, Subhanpura were flooded.
