# Geotechnical and Geological Investigation of Critical Slopes along Balipara-Charduar-Tawang Road in Vartak area, Arunachal Pradesh, India

Singh Deepak Kumar, Verma Amit Kumar\* and Singh T.N.

Department of Civil and Environmental Engineering, Indian Institute of Technology Patna, Bihar, INDIA

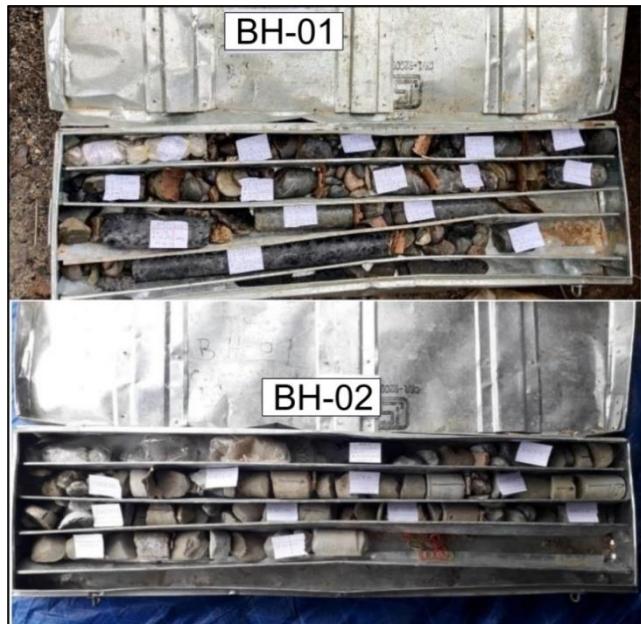
Fig. 4: Core boxes of two drill holes

**Borehole investigation:** Geotechnical borehole investigations were conducted to establish the lithology of both slopes. Soil samples were obtained using a split spoon sampler through the standard penetration test (SPT) at intervals of 1.50 m as per codal provisions. Diamond coring with a double-core barrel was used when formations were encountered in the borehole. Two boreholes were drilled on the landslide's surface and complete cores were extracted. These boreholes were drilled at specific locations, 15.0 m below the average existing ground level. Core logging (Fig.

4) and various laboratory tests were conducted on rock and soil samples. A single borehole of 15 m depth was drilled at each slope to ascertain the lithology.

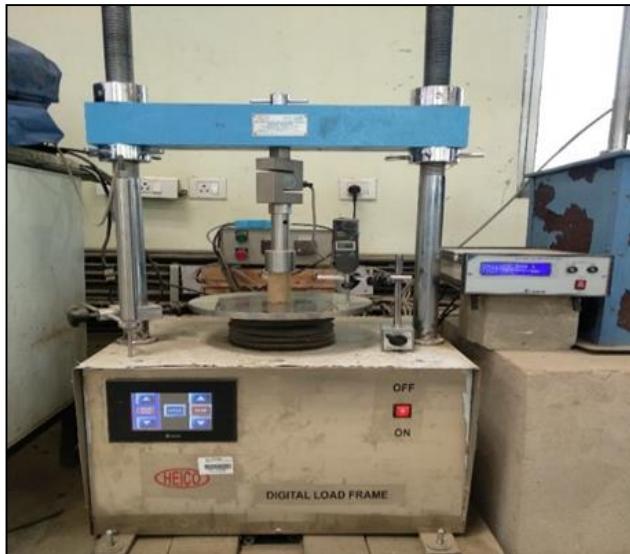
**Fig. 5:** Uniaxial compressive strength testing setup for rock and soil samples.

**Laboratory investigations:** Laboratory tests were conducted on soil and rock samples obtained from two boreholes following the relevant Indian standard codes (Table 2). The purpose of the test was to determine various engineering properties. The soil analysis encompassed grain size analysis, specific gravity determination, natural density assessment, dry density measurement, natural moisture content determination, cohesion evaluation, friction angle determination and Atterberg's limit tests including plastic and liquid limits. Meanwhile, rock sample analysis involves

UCS (Fig. 5), specific gravity, point load and tensile strength.
