# Living with a catastrophe at the cost of life: Illegal and Risky settlement on the hill slope in Chattogram city

Islam Syed Monirul

## Abstract

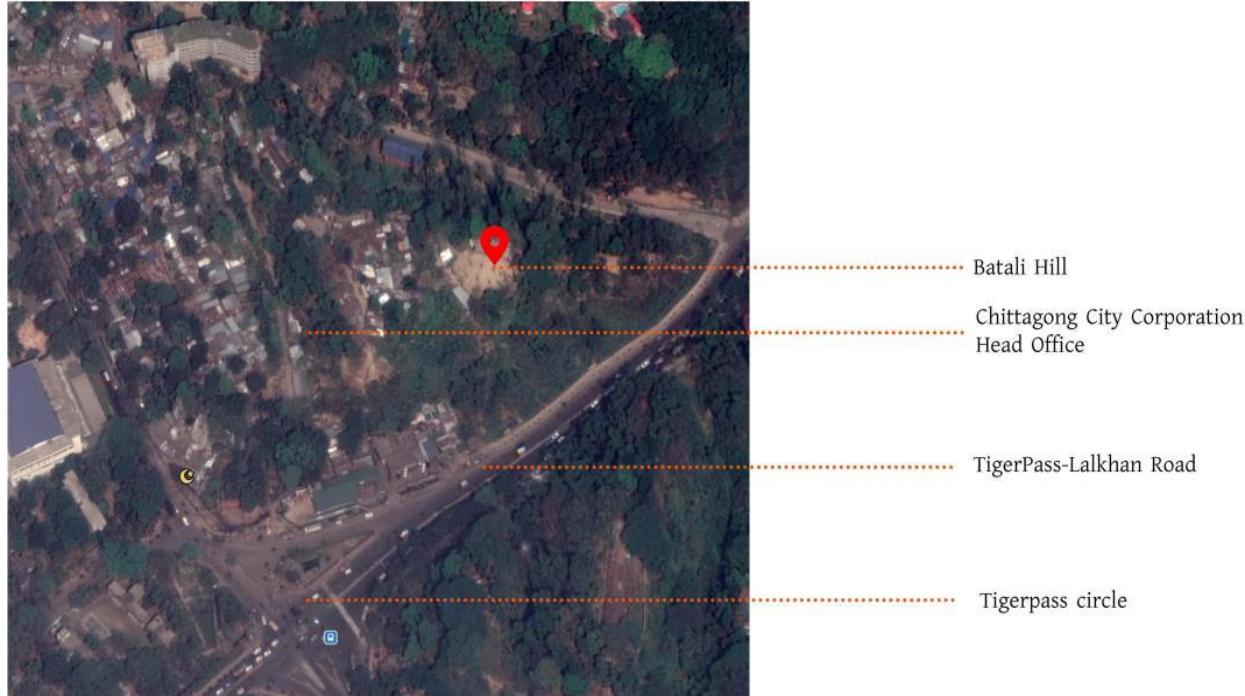
Figure 2: Google image Batali Hill

Batali hill settlements are densely clustered, with houses made of bamboo, tin and other fragile materials. These settlements severely disrupt the hill slope and land cover. Hill cutting and vegetation loss have damaged Batali Hill's ecosystem. The natural drainage system of the hill is obstructed, causing water to stagnate during heavy rain,

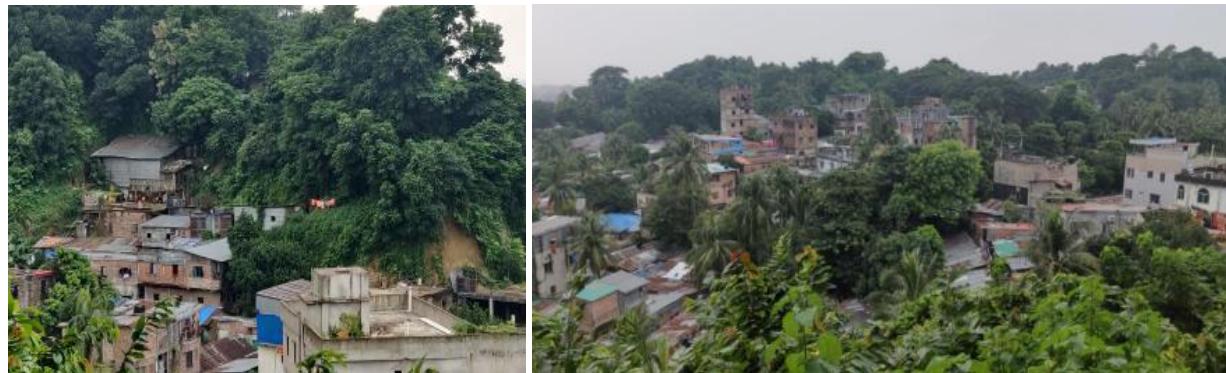
**Figure 5: The images of Motijharna area. Source: Author**

**Landslide History:** Landslides in Motijharna are common during the rainy season. However, major landslides occurred in 2013, 2007, 1996, 1994, 1991 and 1982, causing significant casualties and property damage, severely disrupting the ecosystem. It is sorrowful that many settlements remain on the hilltop and downslope. The sandy soil of Motijharna hill has become increasingly steep in recent years, nearing vertical.

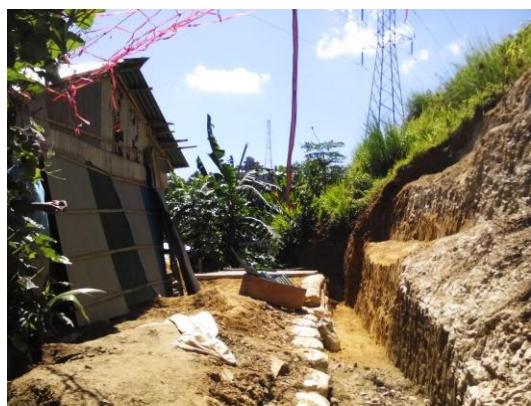
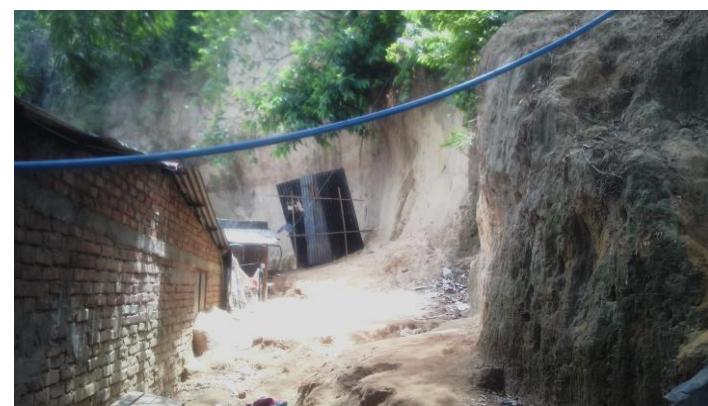
Figure 10: Landslides happen due to the destruction of a hill foot.

**Hill cutting:** Hill cutting for land development, housing and infrastructure in Chattogram city is common. Rapid urbanization in CMA attracts many migrants, mostly from lower-income groups, who want to live near their workplaces for low rent. Some influential individuals illegally occupy Government hills near the city center, such as Batali hill and Motijharna hill, to build illegal settlements on slopes or at the base.

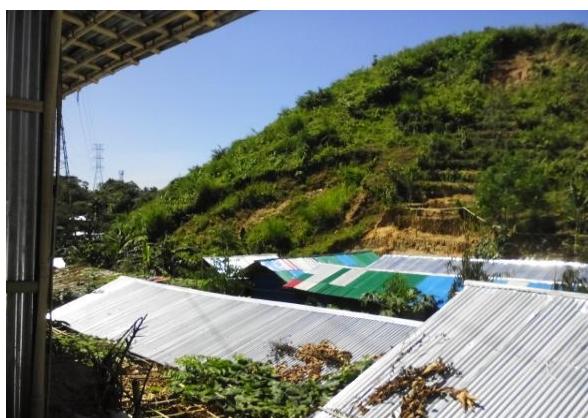
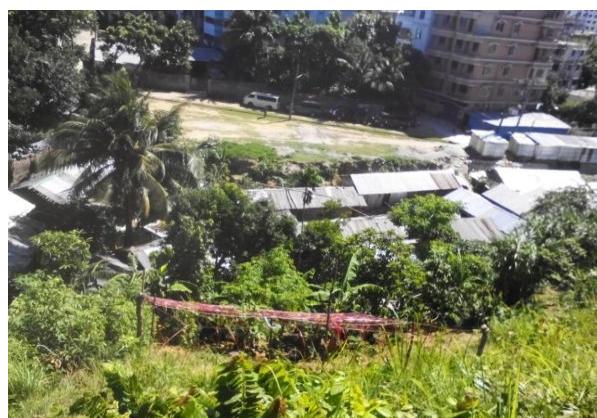
Figure 11: Landslides happen due to hill cutting for construction purposes

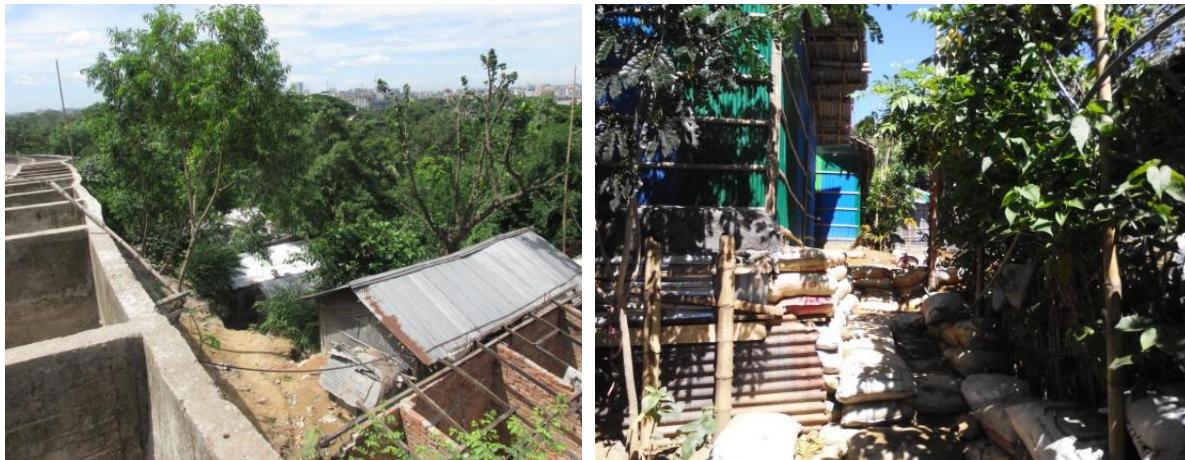
**Figure 12: Prevention measure through engineered and local methods.**

**Technical measures for protecting against landslides:** Landslides in CMA cannot be entirely prevented, but mitigation measures may reduce their occurrence and impacts. Preventive techniques should be implemented in prone areas, such as retaining walls, deep-rooted trees, improved drainage systems, slope stabilization (using erosion-controlled blankets, geo-cell fencing) and flexible debris barriers. Awareness is also crucial for residents in landslide-prone areas. They must understand the risks,
